Building Name	Mir Muhamedova dzamija Muhamed Mustaj-begova dzamija Mosque of Mir Muhamed Mosque of Muhamed Mustaj Beg	Building Use	religious
Street Name		Building Type	mosque
District	Cajnice	Building Setting	city
Neighborhood		Building Condition	completely destroyed
Town	Cajnice	Adjacent Buildings	in good condition
GPS Coordinates	N 43° 33 27 E 19° 04 16		
Construction	17th c. (1618)		
Historical Period	Ottoman		
Official Status	listed monument

Destruction of Cultural Heritage in Bosnia-Herzegovina, 1992

Building Name Dzamija Sinan-bega Boljanica
Sinan-begova dzamija
Mosque of Sinan Beg Boljanic

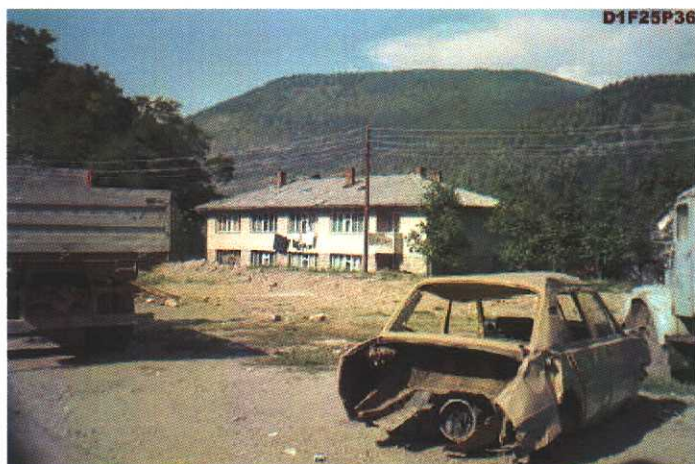
photo from: Council of Europe (1998) - empty site of the razed Mir Muhamed Mosque in Cajnice

Mosque completely destroyed, ruins removed, site bulldozed and used as a dump for junked cars and trucks.

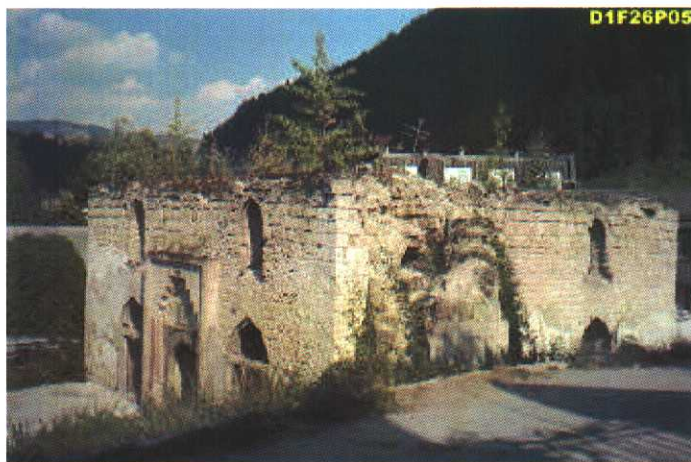
photo from: Council of Europe (1998) - remains of Sinan Beg Mosque as of 1998: minaret blown away, dome and roof gone

Mosque heavily damaged, minaret destroyed by blast, dome and roof destroyed, interior gutted with vegetation observed growing inside, only perimeter walls left standing at the time of 1998 assessment visit by Council of Europe team.

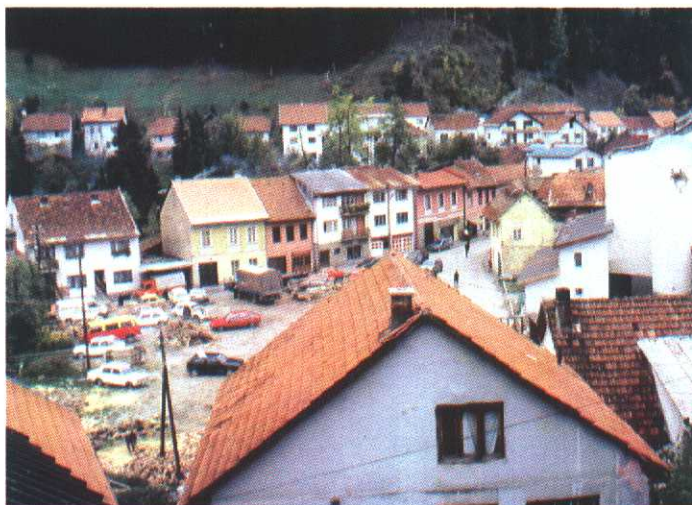
photo by Machiel Kiel (1999) - empty site of razed Sinan Beg Mosque; note small yellowish house at top right of the cleared site, also visible at right of Mosque in pre-war photo (below)

Less than two years later, experts visiting the site (Dr Machiel Kiel and the UNESCO representative) found the mosque completely destroyed, all the ruins removed, the site levelled and turned into a parking lot.

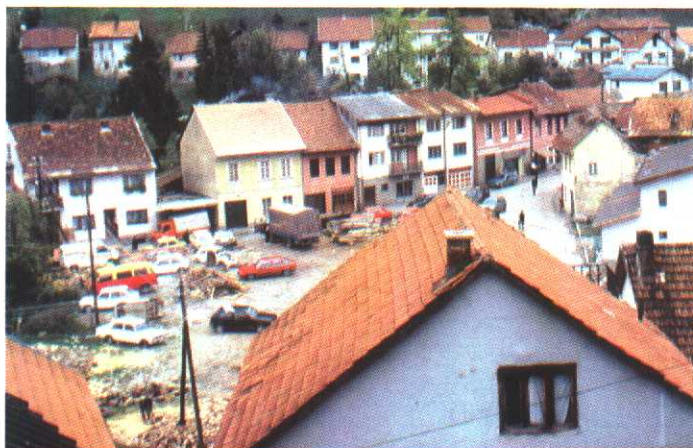
photo by Machiel Kiel (1999) - empty site of razed Sinan Beg Mosque complex, site of razed Turbe of Sinan Beg at left

Turbe completely destroyed, ruins removed, site levelled and turned into a parking lot.

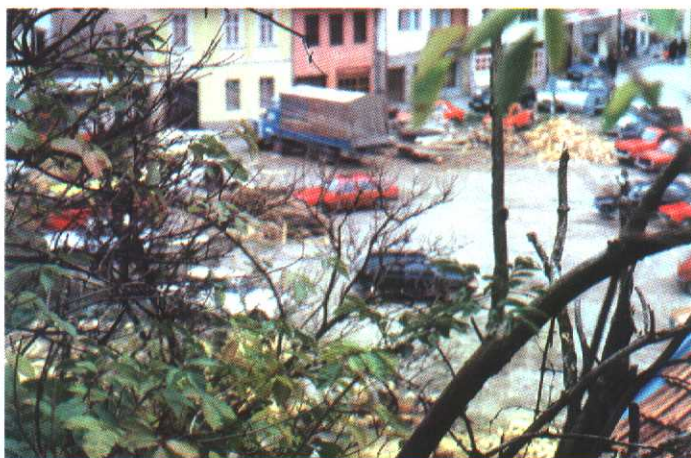
photo by Machiel Kiel (1999) - empty site of razed Sinan Beg Mosque complex, site of Turbe of Sinan Beg's Son at right

Turbe completely destroyed, ruins removed, site levelled and turned into a parking lot.

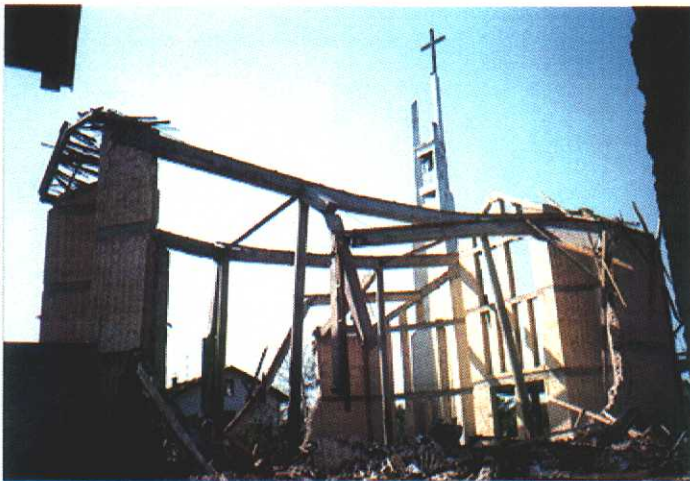
photo from: Roman Catholic Diocese of Banja Luka (1995)

St. Joseph's Church in Trn, which serves a suburban parish of Banja Luka, was destroyed with explosives according to information and photos obtained from the Roman Catholic Diocese. The interior is gutted, the roof and side walls are gone; the apse wall and the entrance facade remain partly intact, as does the church steeple.

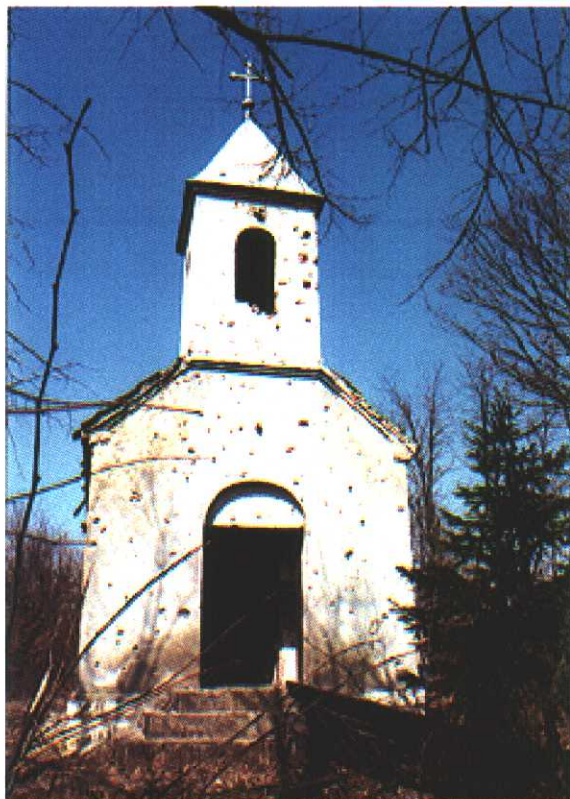
Interior of church smashed up and looted, exterior shot up, full of bullet holes.

photo from: *Raspeta crkva u Bosni i Hercegovini*

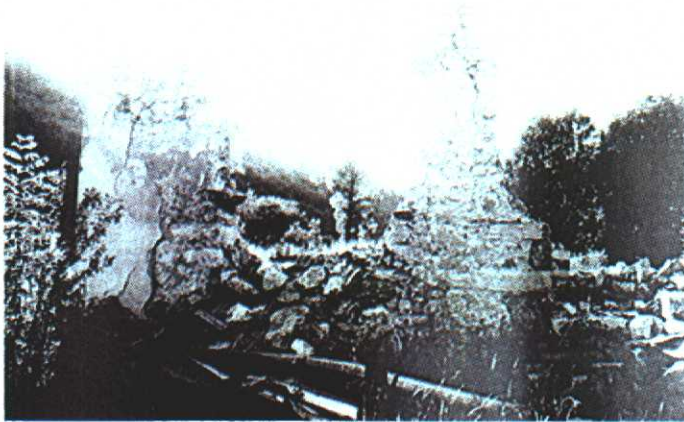
photo from: K.Zukic, *Slike zlocina* (1999)- ruins of Old Mosque at Jabuka

Mosque almost completely destroyed; only stone foundations and some fragments of perimeter walls remain. Damage appears to be due to blast.

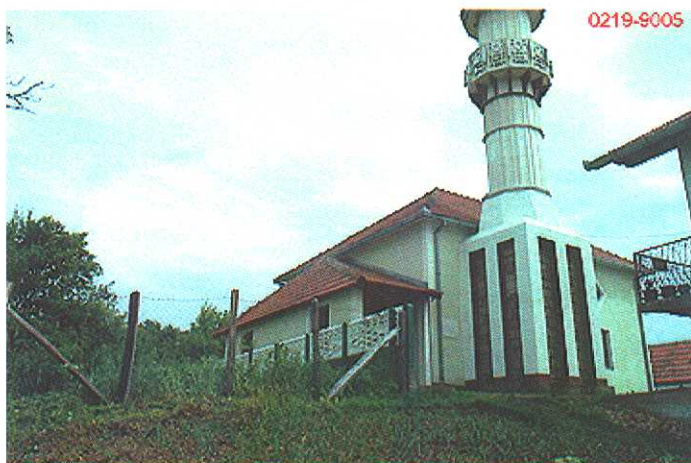
photo from: ICTY (05/2002) - newly rebuilt minaret and roof of Mosque at Godus.

Mosque heavily damaged by shelling, according to information received from Islamic Community.

Roof replaced, minaret completely rebuilt since the end of the war.

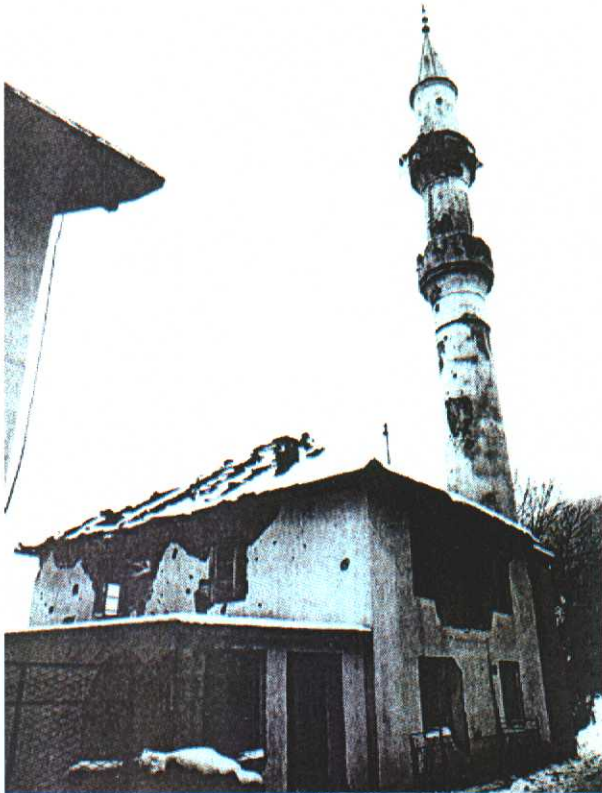
Minaret, roof and perimeter walls damaged by multiple projectile impacts, signs of extensive blast damage.

photo from: K.Zukic, *Slike zlocina* (1999) - note projectile damage to perimeter walls and roof, shell holes in minaret

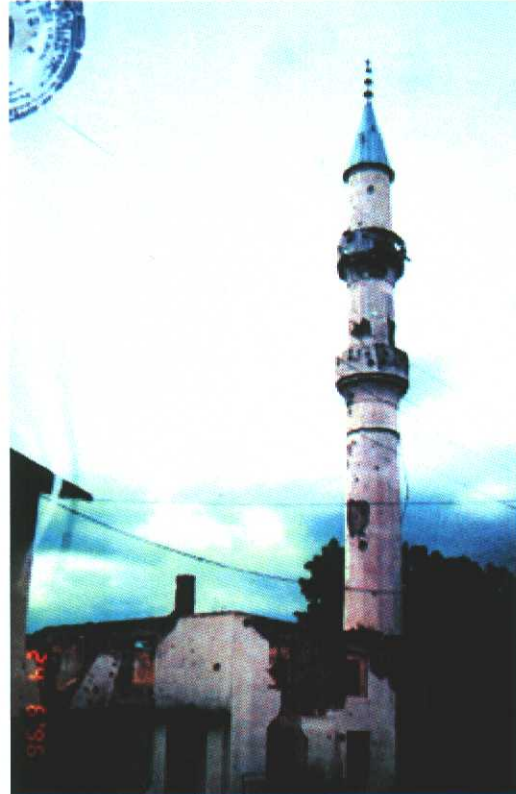
photo from: Regional Museum, Bihac (1996) - note projectile damage to perimeter walls, shell holes in minaret

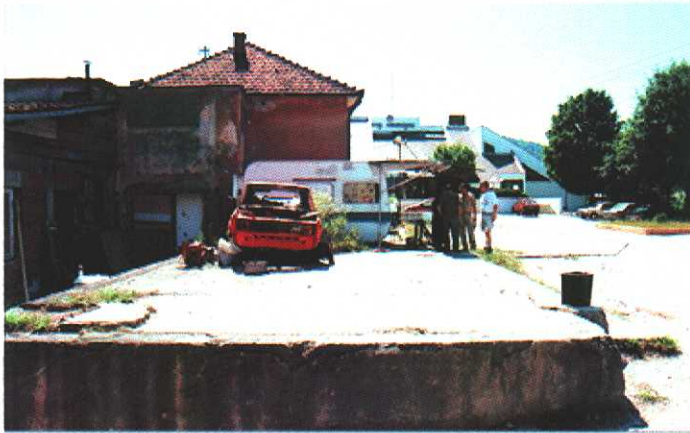
photo by: András Riedlmayer (07/2002) - foundations of razed Dervish Lodge and Shrine, saints' tombs under car at far end.

Dervish lodge (musafirhane) and Turbe (shrine) is completely, razed down to the bare foundations. A junked car is parked atop the saints' tombs.

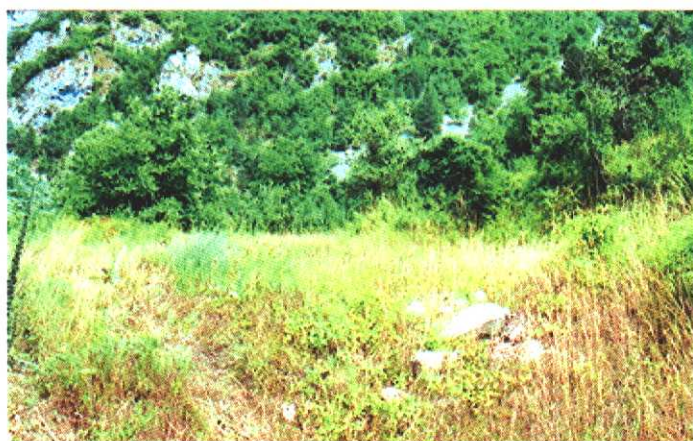
photo by: András Riedlmayer (07/2002) site of razed mosque, viewed from same vantage point as photo below.

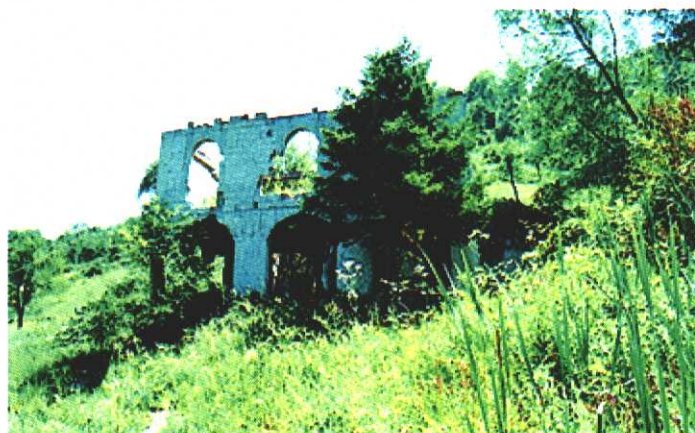
Mosque badly damaged by explosives, roof and minaret gone, interior gutted, perimeter walls show damage from blast but are partly intact to roofline. Mosque's interior filled with rubble and overgrown with vegetation.

photo by: András Riedlmayer (07/2002) - entrance facade of

ruined Mosque at Drinjaca

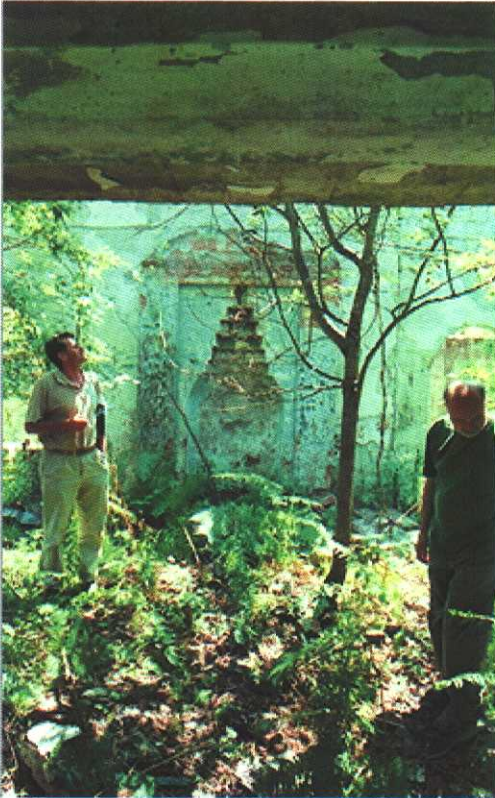
photo by: András Riedlmayer (07/2002) - gutted interior of Drinjaca Mosque, with prayer niche (*mihrab*)

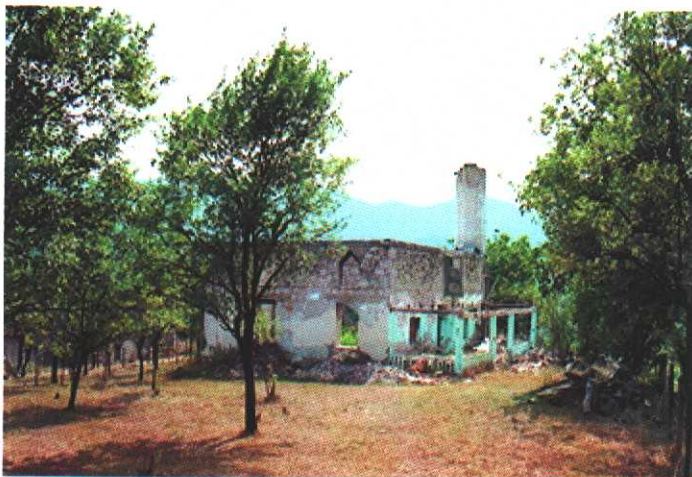
Minaret decapitated, mosque entirely burned out, roof collapsed, interior gutted, portico burned, perimeter walls still standing to roofline.

photo by: András Riedlmayer (07/2002)

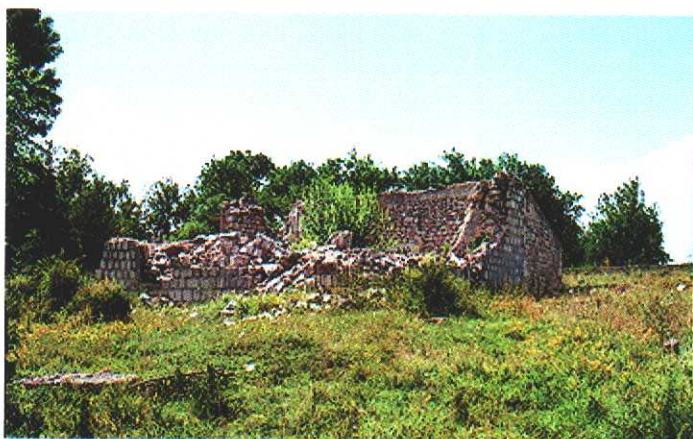
photo by: András Riedlmayer (07/2002) - ruins of mosque, entrance facade at right

Front facade of old mosque still standing, the other three perimeter walls, the roof, interior, and minaret completely destroyed; many stones scattered to a considerable distance; signs of blast damage.

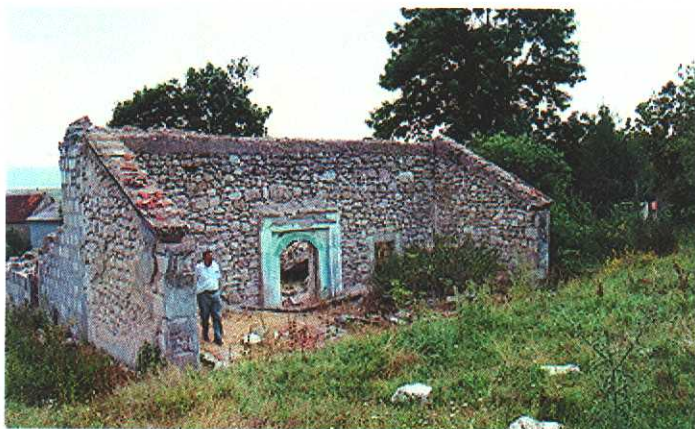
photo by: András Riedlmayer (07/2002) - entrance facade

of Odzak Mosque

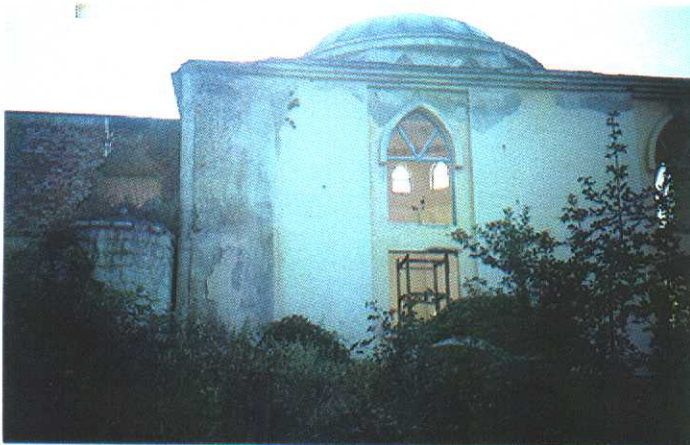
photo from: Islamic Community of Dobož - side view; stump of toppled minaret and hole in wall of mosque visible at left

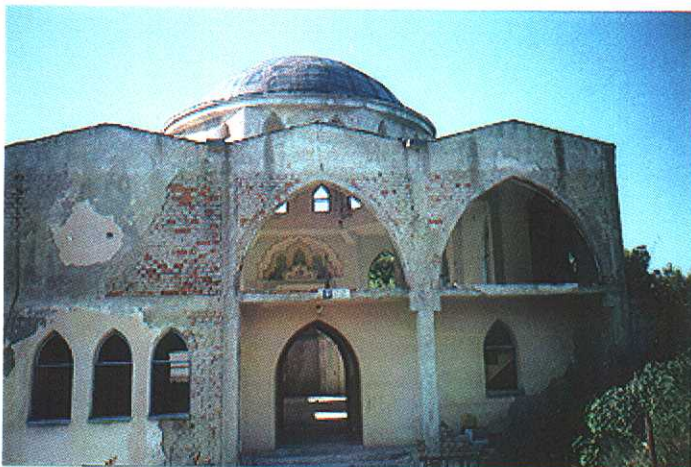
photo from: Islamic Community of Dobož - view of damage to

entrance facade of mosque, stump of minaret at right

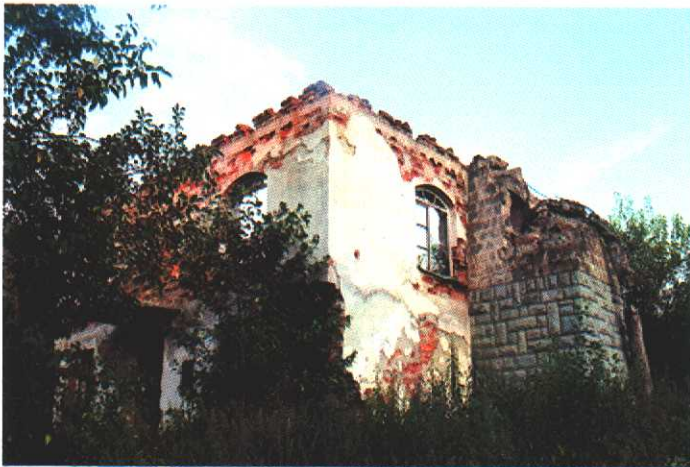
photo by: András Riedlmayer (07/2002) burned-out mosque with stump of blown-up minaret at right

Mosque burned out, minaret blown up with only a stump remaining, perimeter walls still stand up to roofline.

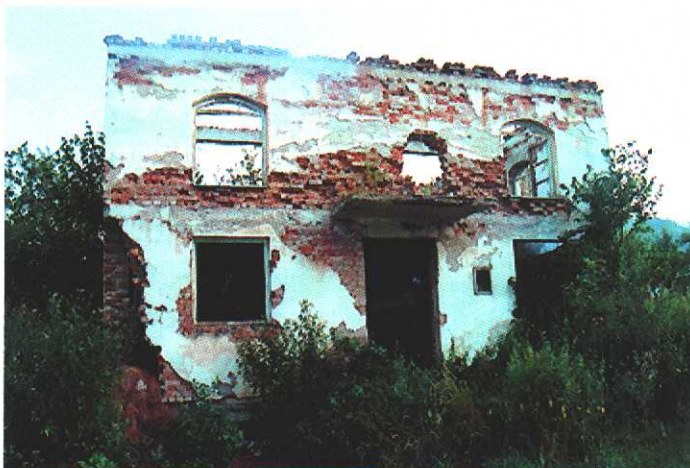
photo by: András Riedlmayer (07/2002) entrance façade of

mosque at Voljevica.
